New Pogo Socket with Replaceable Top Plunger

Yee Sun Kang
TSE Corporation

New Pogo Socket with Replaceable Top Plunger 'Tango Socket'

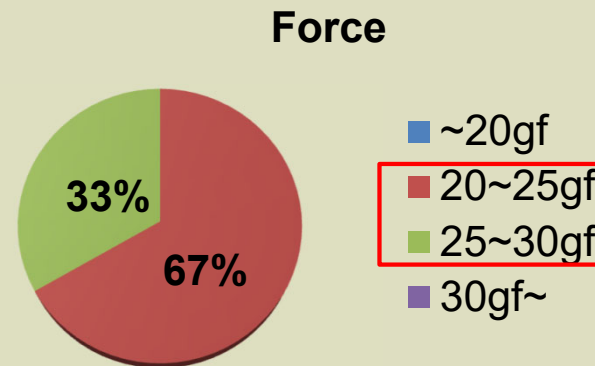
Mechanical Spec

Recommend Operation Stroke : 0.45mm

Operation Full Stroke : 0.60mm

Spring Force : 25gf±20% (@0.45mm)

Life Span : >300,000 (Mechanical)

Resistance : <100mΩ (Average)

→ 100% Spec In

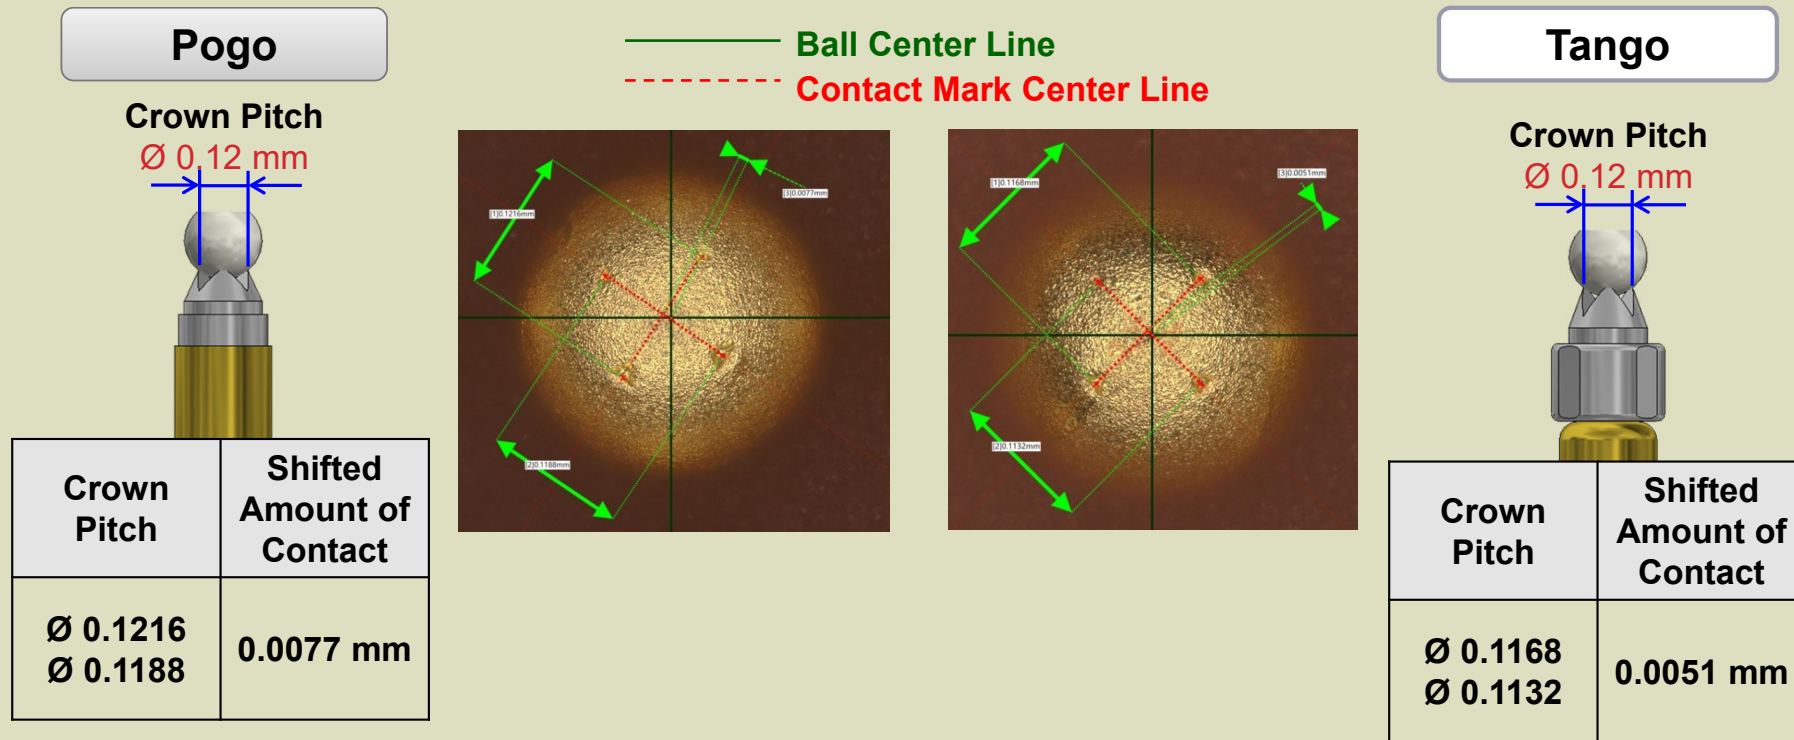
Contact Mark Result

- No significant difference in contact mark confirmed between Tango Pin and Pogo Pin.
